# Your survey report

Property address

South Surveyors - SAMPLE REPORT

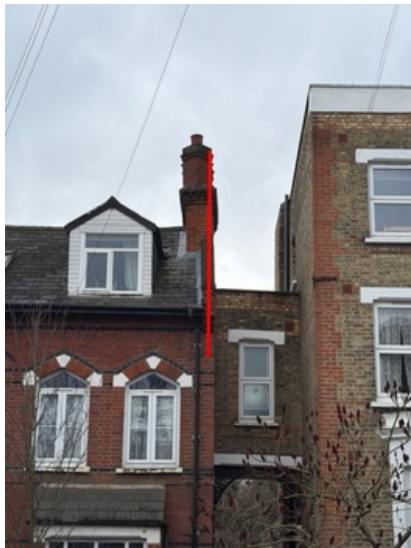
time, the condition of the mortar joints, chimney pots, flaunching, and flashings should be comprehensively assessed and repaired where required. Where flues are no longer in use, they should be appropriately capped at roof level to prevent rainwater ingress into the flue structure. Adequate ventilation should also be provided to redundant flues to reduce the risk of condensation and internal dampness within the chimney breast.

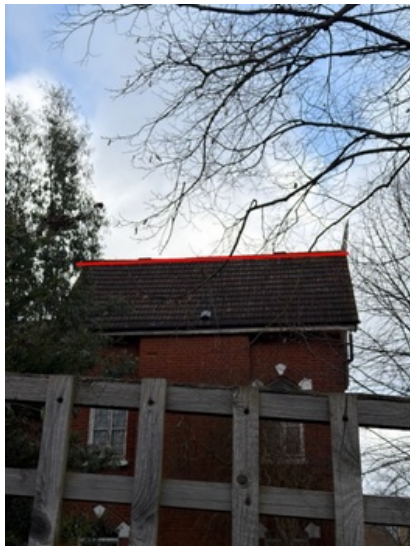
effective strengthening of the roof frame at the time of previous alterations or re-roofing works. It is also possible that the use of heavier concrete tiles during the previous re-roofing works has contributed to the structural stress experienced by the original Edwardian roof frame over time, as the timbers were not designed to carry this additional weight. Further investigation by a suitably qualified roofing contractor or structural engineer is recommended to confirm the adequacy of the roof structure and identify any remedial works that may be required. Prospective purchasers are strongly advised to commission this investigation and obtain a written report and costed schedule of works prior to legal commitment to purchase. There is no apparent method of ventilation to the roof void. Adequate ventilation is essential to reduce the risk of condensation forming within the roof space, which in turn reduces the likelihood of timber decay and premature deterioration of the roof coverings. In the absence of effective ventilation, warm moist air rising from within the property can accumulate within the roof void and condense on the structural timbers, leading to rot, and on the underside of the roof coverings, accelerating their deterioration and shortening their serviceable life. A reputable roofing contractor should be instructed to assess the roof void and advise on the installation of appropriate ventilation measures in compliance with current building regulations and relevant British Standards. Quotations for this work should be obtained prior to legal commitment to purchase.

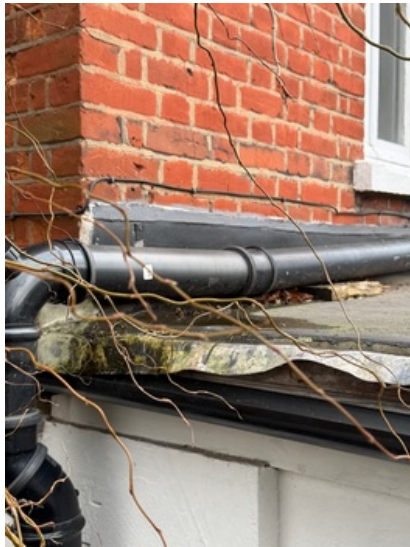
The property has been fitted with UPVC rainwater goods (gutters and downpipes), which are in want of repair and require attention. Several defects were noted from ground level, including water staining at some joints and unjoined sections of guttering. The alignment is poor in places and seepage of rainwater from the guttering was apparent. However, it was not raining at the time of inspection; therefore, the water-tightness of the joints could not be fully assessed. The gutters and downpipes should be observed during periods of rainfall and any leaking joints re-sealed or replaced as necessary. Moss and debris were noted to the guttering and should be cleared soon to avoid blockages which may lead to overflow and consequent damage to timber elements, masonry and the structure generally. You should arrange for repairs to defective sections and adjustments to poorly aligned guttering to be carried out as a matter of priority. UPVC rainwater goods are relatively maintenance-free but do require regular cleaning and periodic

re-sealing of their joints. Downpipes need to be checked regularly to ensure that joints have not come apart. PVC rainwater goods are jointed using rubberised gaskets which tend to perish over time, and periodic maintenance and replacement of seals will be required to maintain weather-tightness. We recommend that you obtain estimates for the necessary repairs from a suitably qualified roofing or building contractor prior to exchange of contracts.

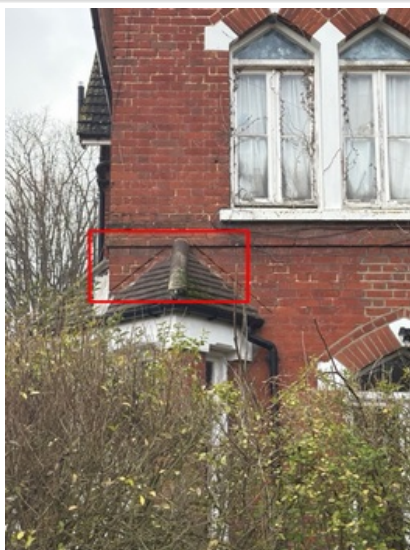
The main walls are of solid brick construction measuring approximately two hundred and thirty millimetres overall where measured. Solid walls are structurally robust but can be prone to problems of rain penetration and condensation compared with modern cavity wall construction, as they rely on wall thickness and external pointing condition to prevent moisture ingress. We have noted several defects which should be repaired soon to prevent further deterioration and protect the building fabric. A number of spalled bricks are present to the external elevations. These require proper cutting out and replacement with new bricks to match existing. Spalling occurs when brickwork becomes saturated with water due to rainwater penetration or moisture absorption. When the water within the brick freezes during cold weather, it expands and causes the face of the brick to break away. This is a progressive condition that will worsen if left untreated, as each cycle of wetting and freezing causes further damage. Spalled bricks should be carefully cut out without damaging surrounding brickwork, and replaced with matching new bricks of similar type, colour, and texture. The underlying cause of moisture penetration, such as defective pointing or inadequate

protection from rainwater, should also be addressed to prevent recurrence. Cracking is present to render and brickwork above external doors and windows. This cracking to the mortar joints indicates disturbance to the lintel support over the openings. As a consequence, brickwork may be resting on the window and door frames beneath, which could cause further deterioration, distortion of openings, and damage to frames if not addressed. We recommend that the lintels be assessed by a qualified structural engineer or experienced building surveyor, and appropriate support reinstated where necessary. This may involve installation of replacement lintels or additional structural support above openings. The cracking should be monitored to determine if movement is ongoing or has stabilised. Areas of worn and missing pointing were identified at a number of locations including rear wall and side elevations. Defective pointing allows water to penetrate into the brickwork, which can lead to internal dampness, frost damage and spalling of bricks, deterioration of the mortar and brickwork, reduced thermal performance, and potential structural issues if water penetrates deeply into the wall construction. Contractors should be instructed to provide quotations for raking out and repointing defective brickwork. The repointing work should be carried out using an appropriate mortar mix compatible with the age and type of brickwork. Typically, a lime-based mortar or weak cement mortar should be used for older properties, as strong cement mortars can cause damage to softer bricks and prevent the wall from breathing properly. The repointing should be carried out to a good depth, removing defective mortar to at least fifteen to twenty millimetres, and finished with appropriate detailing to match the existing pointing style. Stepped hairline cracking was present in a number of locations, following the mortar joints in the characteristic stepped pattern. This type of cracking is typically caused by slight seasonal movement of the building as it responds to changes in temperature, moisture levels, and ground conditions. Solid wall construction is particularly prone to such movement due to thermal expansion and contraction, and seasonal changes in the subsoil, particularly if constructed on clay soils subject to shrinkage and expansion. The cracking observed is not of structural significance at this stage and appears to be minor movement that has stabilised. However, repointing of the affected brickwork should be completed to prevent water penetration occurring through the cracks, which could lead to internal dampness and further deterioration. You should expect that further minor seasonal movement may occur in the future, which is a normal characteristic of solid wall construction and buildings on clay or other reactive subsoils. This type of minor movement does not usually indicate any serious structural problems, but the building should be monitored, and any new or widening cracks should be investigated if they appear. NOTE: The foundations have not been exposed or inspected, as this would require excavation which is beyond the scope of this survey. Whilst there is a risk of unseen defects to foundations or below-ground construction, there are no above-ground signs of defective foundations at the time of inspection. The building is likely to be constructed upon a subsoil subject to seasonal shrinkage and expansion, which can cause structural movement, particularly during periods of prolonged dry weather or heavy rainfall. This is characteristic of the local geology and should be anticipated as normal behavior for properties in this area.

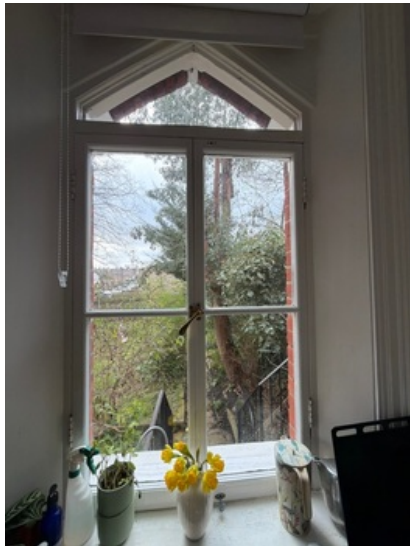
The windows are of timber construction and several areas of softness and rot are evident, requiring repair to prevent further deterioration. Although we have inspected a sample of accessible timber elements, the possibility of hidden defects being present to concealed timbers cannot be entirely ruled out. It should be possible with routine maintenance to repair and refurbish the windows, and you may wish to seek quotations for these works from a qualified joiner prior to commitment to purchase. The external decorations will need to be carried out soon to avoid further deterioration of the timber. Regular redecoration will be required, typically on a three to five-year cycle dependent upon the quality of paint coating and level of exposure to the elements. Some windows would not open under hand pressure at the time of inspection. These should be investigated and overhauled as necessary, as seized mechanisms or painted-shut sashes may indicate underlying issues with the timber or hardware. You should be prepared to repair or replace some of these windows if they cannot be successfully freed. Window components can become faulty over time due to lack of maintenance, weathering or general wear and tear. Common defects include failed putty glazing,

rotten sills and bottom rails, defective sash cords or mechanisms, and worn hinges or stays. We recommend obtaining estimates for repair, draught-proofing and redecoration of the timber windows, and factoring these costs into your offer or negotiating an appropriate reduction in the purchase price.

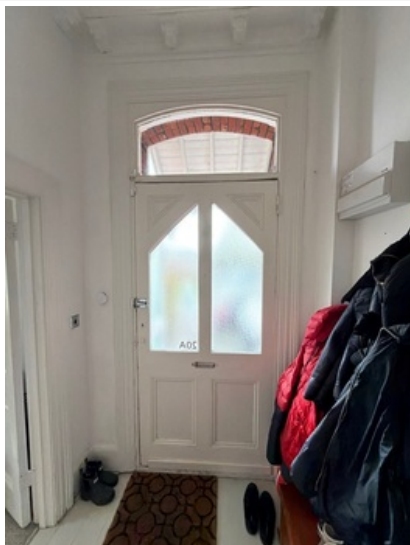
The soldier brickwork surrounding the door frame should be assessed by a suitably qualified builder and monitored on an ongoing basis. Soldier courses, where bricks are laid on end vertically above an opening, are susceptible to movement, cracking, and displacement, particularly in older properties where the original lintels or arches may have deteriorated or where settlement has occurred over time. Any signs of cracking, bowing, or movement in this area should be investigated promptly, as failure of the soldier course can have implications for the structural integrity of the opening and the masonry above. The main doors are of timber construction and appear to be the original installation, to which no significant defects were noted at the time of inspection. The external decorations are currently in good condition and will require regular maintenance to keep the timber in satisfactory condition. Without a protective finish, timber elements will quickly deteriorate, requiring extensive and costly repairs. To prevent this, the external surfaces should be redecorated periodically, typically on a three to five-year cycle dependent upon the quality of the paint coating applied and the level of exposure to the elements. The door furniture and components are adequate

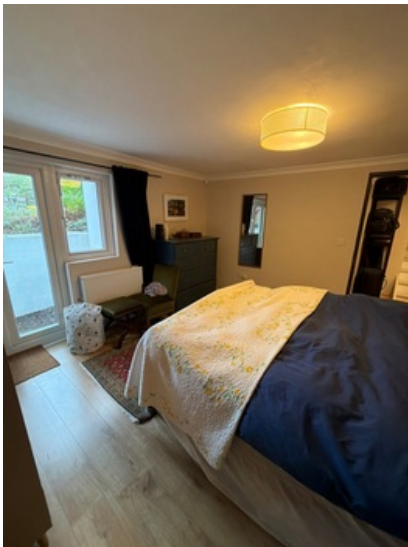
Internal walls comprise a mixture of solid construction (probably brickwork) and modern timber stud partitions with plasterboard linings. There is tiling to the 'wet' areas (kitchen and bathrooms) to reduce the risk of moisture and water ingress. Internal walls appear structurally satisfactory however there is significant evidence of external structural movement. There is some general cracking and distortion, which is quite common in all properties, particularly at the margins of the ceilings and around doors and windows. This is caused by shrinkage, thermal movement, and other normal building settlement. This is not a matter that should cause you undue concern, being largely cosmetic in nature, and generally only careful preparation and cosmetic repair prior to redecoration should be anticipated. Moisture content readings were taken throughout the ground floor walls with an electronic moisture meter, and elevated readings indicating dampness were noted to the external walls. This suggests that the damp-proof course is not operating effectively and/or the main walls are allowing water penetration through defective external render, failed pointing, bridging of the damp-proof course, or other causes. It has been suggested there was some

damp works however you will need to seek quotations from Property Care Association (PCA) registered specialists who can undertake a detailed damp investigation to identify the source and extent of the dampness especially in the lower ground. They should provide quotations for remedial works required, which are likely to include installation or renewal of damp-proof courses, removal and replacement of contaminated plaster, and installation of replacement plaster finishes with appropriate membranes or water-resistant specifications. Any remedial works should be accompanied by an insurance-backed guarantee. It is important to address dampness issues promptly, as prolonged moisture penetration can lead to timber decay, damage to internal finishes, and potential health issues from mould growth.

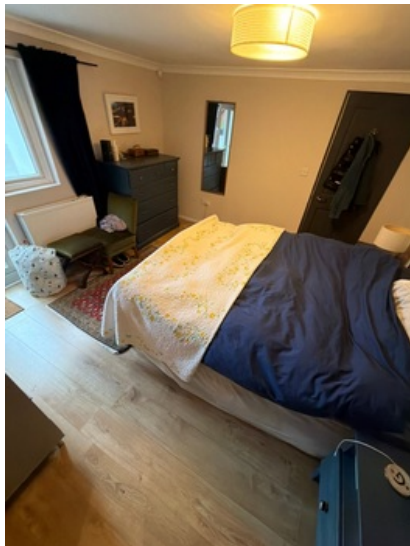
The floors on the raised ground floor are of suspended timber construction. Fitted floor coverings and furniture inevitably restricted the detail of inspection. Comments are therefore based on selected areas where the edges of floor coverings could be turned back to give an indication of the method of construction used and its condition. The risk must be accepted that concealed defects may exist beneath the floor coverings, particularly in areas that could not be accessed or examined. Where walked upon, suspended timber floor surfaces were subject to minor spring and unevenness, but this is within acceptable limits for domestic construction and is not considered to be of structural significance. Indeed, some degree of deflection and unevenness is quite common in older properties, particularly at raised ground floor level, due to historic movement and the characteristics of traditional timber floor construction. The minor spring noted is consistent with the age and type of construction and does not indicate any significant structural concern at this stage. From the hatch on the stair case the suspended timber floors appeared to have adequate sub-floor ventilation which is essential to prevent conditions conducive to timber decay, however some joist appear to need replacing in the near future. However if you plan to open up the space to make your home gym you will need to remove these. The flooring beneath the sanitary fittings could not be inspected as this would involve damaging investigations, including removal of sanitary ware and associated fittings, which are beyond the scope of a normal building survey. The risk of defects existing in these areas must be accepted. Floors beneath sanitary fittings are particularly vulnerable to water damage from leaking pipework, failed sealants, and condensation. If any refurbishment of bathrooms or sanitary areas is undertaken in the future, the condition of the floor structure beneath should be carefully assessed before new fittings are installed. The lower ground floors appear to be of solid construction. The floors appear firm and level underfoot when assessed through the existing floor finishes. The floors did not exhibit any significant signs of deflection, unevenness, or structural concerns during our inspection, which was necessarily limited to walking the floors and observing their response through the existing coverings. Solid floors can consolidate after construction due to settlement of the ground beneath, inadequate compaction of fill materials, or compression of the floor structure under load. This consolidation can lead to the formation of voids or hollows beneath the surface slab, which may not be immediately apparent but can cause problems including loss of support to the floor finish, cracking of tiles or floor screeds, unevenness developing over time, and in extreme cases, substantial deflection or failure of the floor structure. Damage can also be caused by expansion of materials within the sub-floor structure, such as sulfate attack on concrete where sulfates in the ground or fill materials react with concrete causing expansion and heaving, use of inappropriate fill materials that are subject to expansion or breakdown, presence of impurities or contaminants in fill materials, or inadequate damp-proof membranes allowing moisture penetration which can cause deterioration of the floor construction. Solid ground floors should incorporate an adequate damp-proof membrane to prevent moisture rising from the ground through the floor slab. If no membrane was

installed, or if the membrane has failed, dampness can penetrate through the floor causing damage to floor finishes, promoting mould growth, and creating unhealthy living conditions. We were unable to confirm the presence or condition of any damp-proof membrane without intrusive investigation. While no significant defects were apparent at the time of inspection to either the suspended timber or solid floors, you should monitor both floor types for any signs of developing problems. These include new cracks appearing in floor screeds or tiles, increasing unevenness or deflection when walking across floors, tiles becoming loose or lifting, doors beginning to stick or not close properly due to floor movement, visible gaps developing between floors and skirting boards, and any signs of dampness or moisture penetration through floor coverings. When floor coverings are lifted for replacement or refurbishment in the future, you should arrange for thorough inspection of the underlying floor construction on all levels. For suspended timber floors, this should include inspection of joists and boards for rot, insect attack, and structural adequacy, checking of ventilation provision and clearance beneath the floor void, and assessment of any bridging, herringbone strutting, or other structural elements. For solid floors, this should include assessment of the condition of the floor slab, identification of any voids or settlement beneath the surface, checking of damp-proof membrane integrity, and verification that the floor construction is sound and adequately supported.

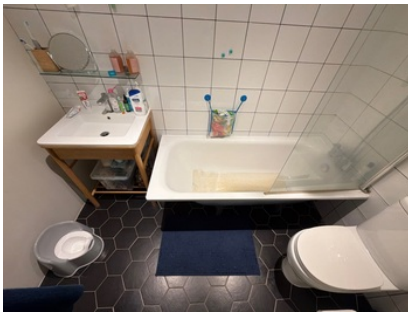
the wall is missing or defective in places. This sealant is the primary defence against water penetration at this vulnerable junction. Without effective sealant, water ingress is likely to occur during normal use of the bath. The vents should be assessed and upgraded accordingly. Most of the distribution and waste pipework is concealed beneath or behind sanitary ware items and whilst there were no obvious signs of leaks, the risk of hidden defects exists. The sealant around the sanitary areas are currently in good condition. It is important to ensure that the seals to the sanitary appliances, in particular baths and showers, are maintained in good condition to avoid damage to adjacent surfaces. The water pressure was checked to several draw-off points and found to be adequate. Water pressure can vary seasonally and during times of demand, both within the property and in the locality. It is recommended that should you wish to install water pressure sensitive items, such as a power shower, that further enquiries are made initially.

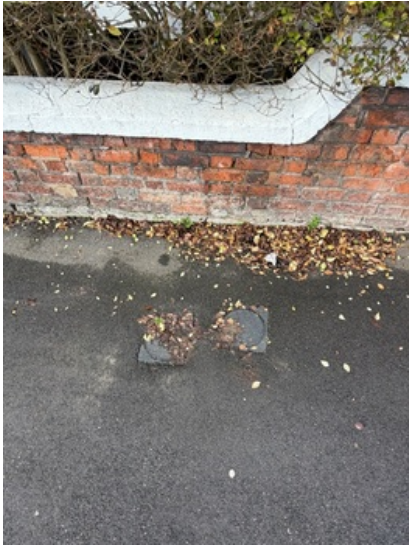
and neighbouring properties and therefore subject to demand related fluctuations in pressure. It would be prudent to confirm whether entire main water feed pipe has been renewed and if it is found lead pipework is still present, this is a material which can be hazardous to health and the original feed pipe should be stripped out and renewed.

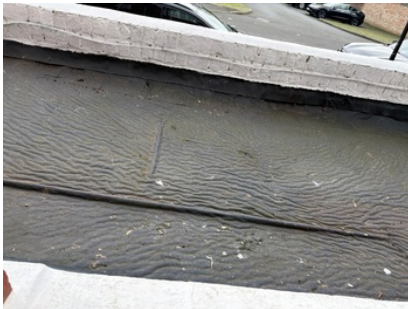
walls should be inspected thoroughly for signs of water staining, dampness, deterioration of brickwork or pointing, and mould growth. Any defects discovered should be addressed as part of the remedial works programme. When the new roof covering is installed, careful attention should be paid to ensuring adequate drainage falls are provided to direct rainwater away from the structure. Inadequate falls are a common cause of flat roof failure, as standing water accelerates deterioration of the covering. The junction between the flat roof and any adjacent walls should be properly weathered with appropriate upstands and flashings to prevent water ingress at these vulnerable junctions.

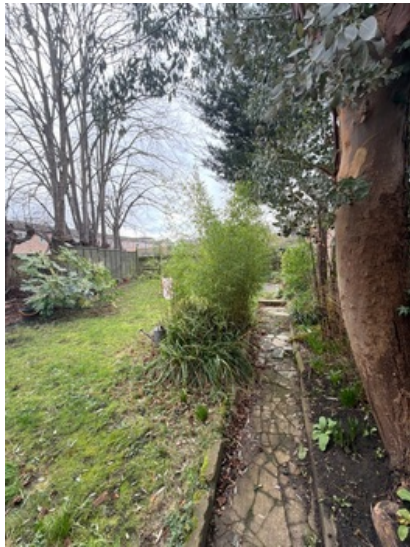
boundary walls to the rear. These types of feature require high levels of maintenance and are currently poor condition. Only on-street parking is available which may be at a premium during peak times. The property appears to be located beneath a flight path and some noise disturbance may be apparent. There is a right of way across the rear of the property. Legal advisers should confirm full details. There is a lamp post close to the property and some light pollution may be apparent. Whilst there was no evidence of any adverse easements, servitudes or wayleaves affecting the property your legal advisers should be asked to verify. See Section H.3.
