LEVEL 3

# Your survey report

Property address  
Sample Report Road  
London  
BRX XXX

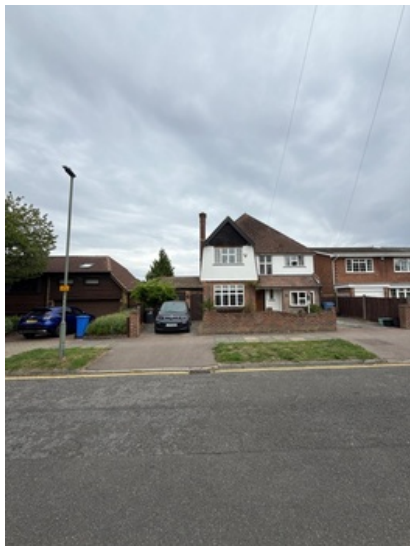
brickwork are in generally fair condition for the age of the property; however, localised areas of weathering, spalling, and mortar loss were observed. Some bricks show signs of deterioration and should be carefully removed and replaced with matching units to preserve the structural and aesthetic integrity of the stack. In addition, areas of eroded mortar joints should be repointed using an appropriate lime-based mortar to ensure continued stability and breathability of the structure. Lead flashings at the base of the stack were observed and appear to be in good condition at the time of inspection. These should be regularly maintained and monitored to ensure they remain weather-tight. It is important to note that the inspection was carried out during dry conditions, and any issues such as leaks may only become apparent during prolonged periods of heavy rainfall. Due to restricted sight lines and lack of access to roof level, the condition of the cement flaunching at the top of the stack could not be confirmed. A closer inspection is recommended to assess whether the flaunching remains sound. Flaunching is commonly subject to weathering and cracking over time, and defective areas should be removed and replaced with a durable, weather-resistant mortar to ensure the pots remain securely bedded and water ingress is prevented. The clay chimney pots themselves appear to be in satisfactory condition. However, several were observed to be open and uncapped. Open flues present a risk of rainwater ingress, debris accumulation, and nesting by birds or other animals, all of which can cause internal dampness or blockages. It is recommended that all disused flues be fitted with ventilated caps or cowls that allow for adequate air circulation while offering protection from weather and pests. It should also be noted that chimney stacks of this age typically lack an integrated damp-proof course. As such, some damp penetration from wind-driven rain may still occur internally, even where the external elements appear to be in reasonable condition. In summary, while no major structural issues were observed from ground level, localised brickwork repairs and repointing are required to maintain the integrity of the chimney stack. Replacement of deteriorated bricks, repointing with lime mortar, renewal of defective flaunching, and fitting of ventilated caps to open pots are recommended. These works should be undertaken by a suitably experienced roofing or conservation contractor following further high-level inspection.

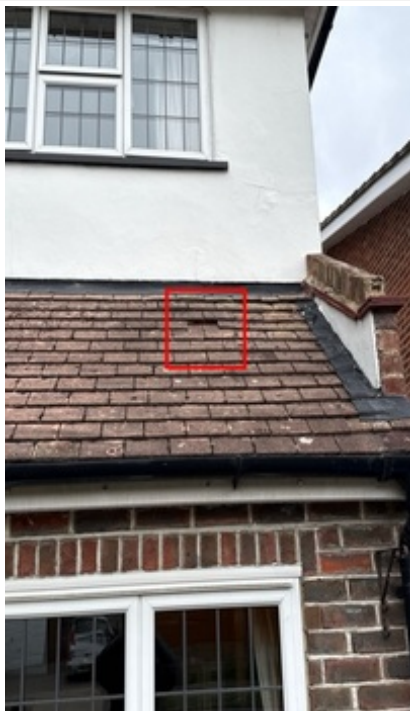
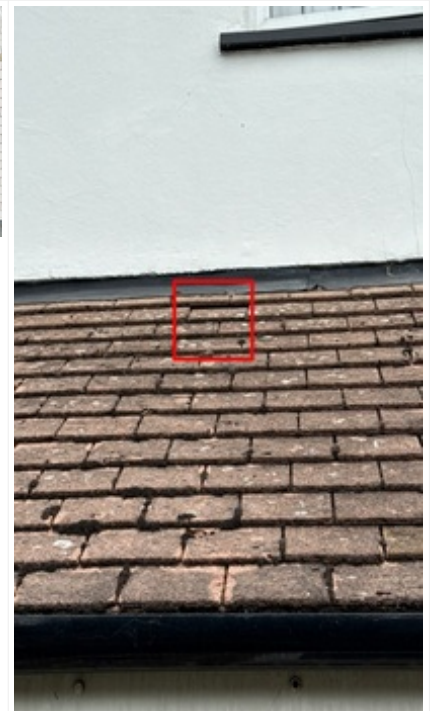
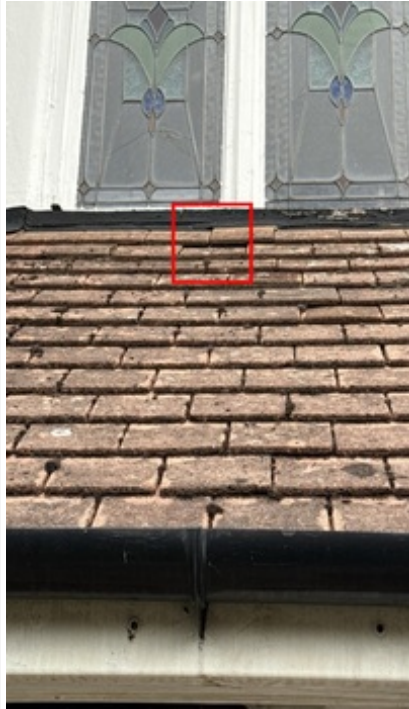
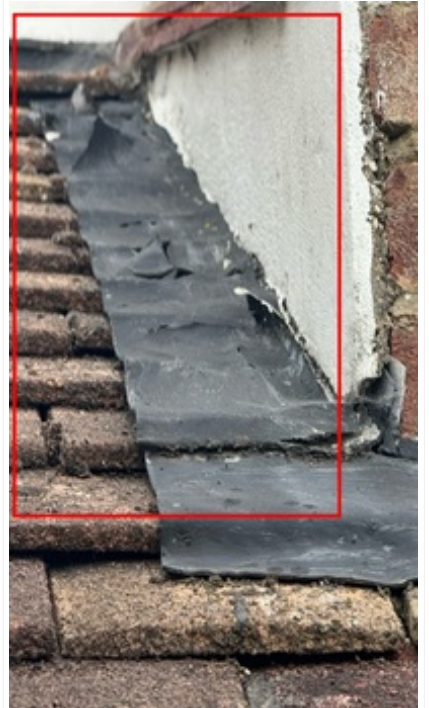
The main pitched roof slopes are covered with traditional clay tiles. Due to access limitations, the roof was inspected visually from ground level across the street and supplemented by aerial views obtained via a UAV. At the front of the property, where the main roof slopes abut, a sloping tiled-lined valley was noted. This valley appears to require repair or replacement in the near future, as the overall roof coverings are approaching the end of their expected service life. Several clay tiles on the roof are slipped, and there are areas where tiles are missing. Additionally, the lead lining around the bay window above the doors is deteriorated and has reached the end of its serviceable life. This leadwork requires urgent attention and repair to prevent water ingress and further damage to the underlying structure. Prompt remedial action is recommended to maintain the integrity of the roof and protect the property from potential moisture-related issues. Furthermore, the lead and/or zinc flashings above the bay windows show clear signs of deterioration and should be replaced as part of the remedial works to ensure continued weather-tightness and prevent further damage to the property. It is important to highlight that the clay tiles are considerably heavier than the original slate tiles typically used in properties of this age and style. This additional imposed load has not been adequately addressed through strengthening of the roof frame, resulting in visible deflection of the roof slopes and distortion of the ridge line. Such structural movement may reduce the longevity of the roof and increase the risk of future defects. Moreover, there is no apparent method of ventilation within the roof void. Adequate ventilation is crucial to prevent condensation build-up, which can lead to timber decay and accelerate deterioration of roofing materials. It is strongly recommended that a reputable roofing contractor be engaged to carry out a detailed inspection and provide advice on introducing suitable ventilation measures. Moss and lichen growth were observed on the roof surfaces. These biological deposits tend to retain moisture and can accelerate the deterioration of the tiles over time. Removal should be undertaken carefully, using appropriate methods that avoid damaging the roof coverings. The ridge tiles currently appear firmly fixed; however, it is not uncommon for ridge tiles to become dislodged during periods of high wind or severe weather. Therefore, occasional re-fixing should be anticipated as part of ongoing maintenance. The mortar bedding and pointing to the ridge and hip tiles is deteriorating, with some areas showing more advanced decay than others. To reduce the risk of wind uplift and water ingress, it is recommended that the ridge and hip tiles be carefully lifted, cleaned, and re-bedded with fresh mortar. Quotations from experienced roofing contractors should be obtained prior to legal commitment to purchase, and the necessary works carried out as part of a planned maintenance programme.

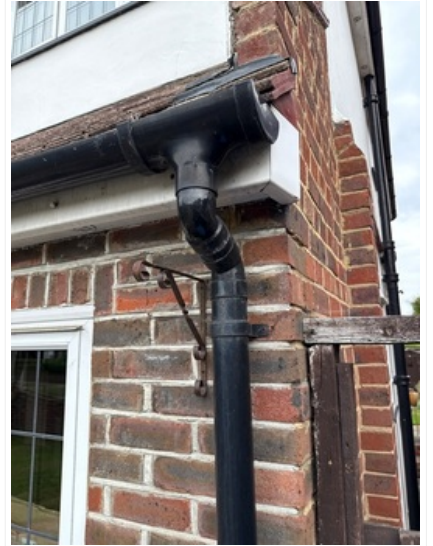
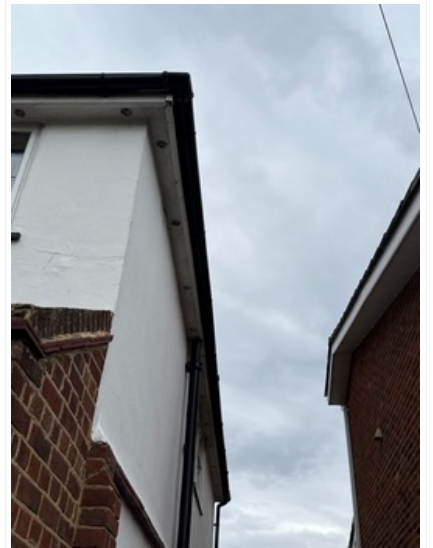
The property is fitted with UPVC rainwater goods, including gutters and downpipes, which generally appear to be in need of some repair. The inspection was carried out from ground level, and during dry weather, so a full assessment of water tightness was not possible. Water staining was observed at some gutter joints, indicating potential leakage, and the gutters and downpipes should be monitored during rainfall to identify any leaking joints that may require resealing or replacement. Several areas exhibit poor alignment, resulting in evident seepage from the rainwater goods. It is recommended that adjustments be made as part of future maintenance to ensure effective drainage and prevent water damage to the building fabric. Moss and debris accumulation was noted within the gutters. This should be cleared promptly to prevent blockages, which could otherwise lead to overflowing and subsequent damage to the timber and structural elements beneath. While UPVC gutters are generally low maintenance, they do require regular cleaning and periodic resealing of joints to maintain their performance. Downpipes should also be inspected routinely to ensure that joints remain secure, as the rubberised gaskets used in these systems are prone to deterioration over time, which can lead to leaks. At the time of inspection, no significant defects were visible; however, due to limitations of access and inspection conditions, the possibility of concealed defects cannot be ruled out.

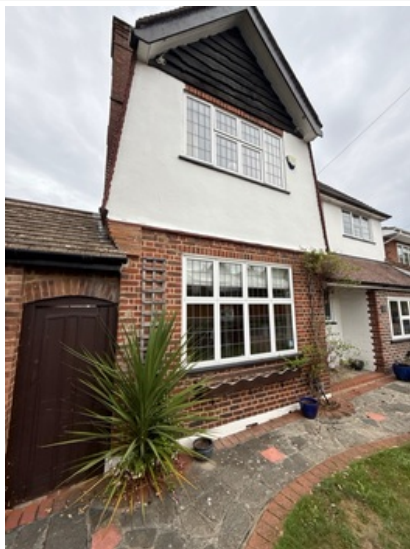
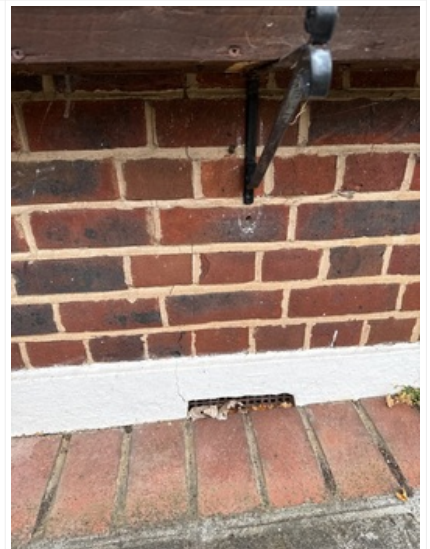
The main external walls are of solid brick construction, measuring approximately 230mm in thickness where accessed and measured. The walls are externally finished with a render coating, which shows several defects requiring prompt attention. Cracking is evident in the brickwork above external doors and windows. This cracking, primarily within the mortar joints, suggests movement and potential disturbance of the lintel supports spanning these openings. As a result, sections of brickwork are now bearing directly on the door and window frames, which may compromise their stability and lead to further deterioration if not addressed. In addition, hollow points were identified within the rendered surfaces, indicating areas where the render has become detached or "blown." These defects are accompanied by cracks in the render, which are allowing moisture ingress. Such conditions increase the risk of damp penetration into the underlying masonry and should be rectified without delay through thorough removal and reapplication of render. Hairline cracking is visible across the rendered surfaces. It should be noted that render can conceal underlying defects such as structural movement cracks or deteriorated brickwork. Confirmation

of these issues would require “hacking back” of the render to expose the masonry beneath, which is beyond the scope of this survey. Consequently, there remains an inherent risk of concealed defects within the wall fabric. It is also important to highlight that the render has been applied down to ground level. This is considered poor practice as it facilitates moisture conduction from the ground into the wall, bypassing the damp-proof course (DPC). This condition increases the likelihood of rising damp and related problems within the property. It is recommended that this be addressed as part of the repair programme. Contractors should be engaged to provide detailed quotations for the necessary repairs, including the removal and reapplication of render, repair or replacement of lintels as required, and any associated brickwork restoration. **Note:** The building’s foundations have not been exposed or inspected during this survey. While there are no visible above-ground signs of foundation defects, it should be understood that the property is likely constructed on subsoil subject to seasonal shrinkage and expansion. This can result in structural movement over time.

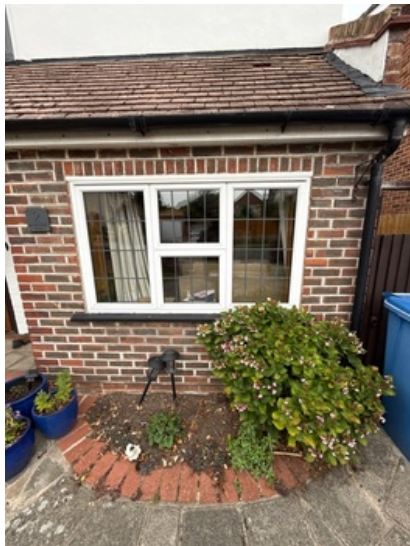
The property features a combination of Crital-style and UPVC double-glazed windows. No significant defects were noted during the inspection. It should be acknowledged that UPVC window frames vary considerably in quality and design, and an in-depth assessment of the individual window mechanisms and materials is beyond the scope of this report. UPVC frames are generally less suitable for piecemeal repairs, and components such as stay mechanisms and fixings may require occasional maintenance or overhaul to ensure proper operation. The double-glazed units should have been installed by a FENSA-registered contractor to comply with current Building Regulations. If a FENSA installation certificate is not available, the installation may not meet regulatory standards. It is advised that legal advisers verify whether a valid FENSA certificate or equivalent documentation exists. Any transferable guarantees relating to the installation should also be identified as part of the purchase process. Refer to Section H.1 for further details. Double-glazed units have a finite lifespan, primarily due to deterioration of the edge seals that maintain the insulated glass unit's integrity. Replacement of these sealed units may be necessary over time.

It is important to note that failed double glazing seals may not be evident during dry weather conditions. At the time of inspection, no signs of condensation between the panes of the double-glazed units were observed. However, it should be recognised that double glazing is susceptible to seal failure, which results in condensation forming between the panes, reducing thermal efficiency and obscuring views.

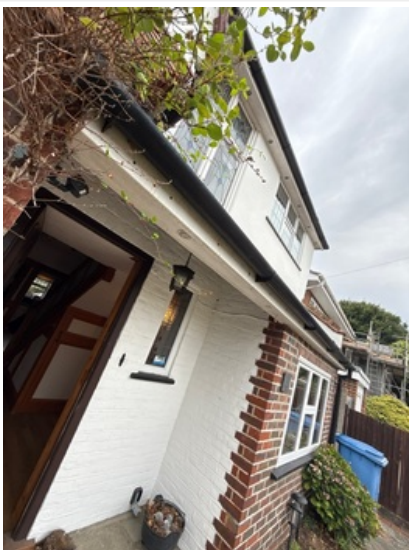
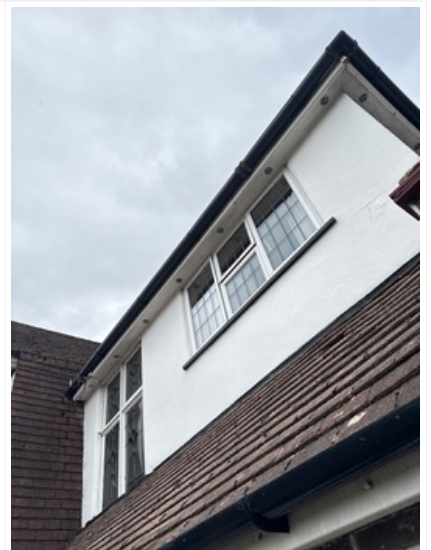
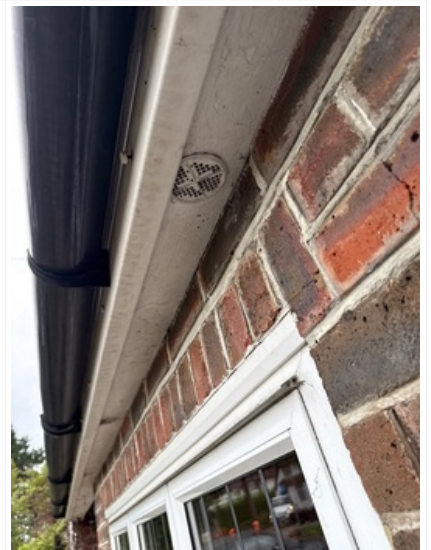
The roof edges are finished with timber fascias and soffits, to which some defects were noted at the time of inspection. The external decorations are showing signs of breakdown and deterioration. It is recommended that new decoration be undertaken within a reasonable timeframe. This should include thorough preparation, such as the removal of all loose and flaking decorative finishes, filling of cracks, and making good any damage prior to priming bare surfaces and reapplication of appropriate decorative coatings. All works should be covered by a long-term guarantee to ensure durability. It is further recommended that the timber be inspected for wet rot, particularly considering the presence of defective rainwater goods,

which may have contributed to moisture ingress. Any affected timber should be replaced with pre-treated materials or carefully prepared by rubbing down to bare wood, followed by infilling where necessary, prior to priming and decoration. To safely carry out repairs and decoration at higher levels, contractors will require appropriate access equipment, such as scaffolding or hydraulic platforms. As this is a traditionally constructed property, it is important that decorative materials compatible with the building's character are used, since modern paints can damage older timber. Contractors with experience in this type of work should be employed, which may result in increased costs. Additionally, older paint surfaces—typically those applied before 1960—may contain high levels of lead and pose a health hazard when disturbed. It is essential to follow the Health and Safety Executive's recommendations when redecorating (see [www.hse.gov.uk](http://www.hse.gov.uk) for guidance).

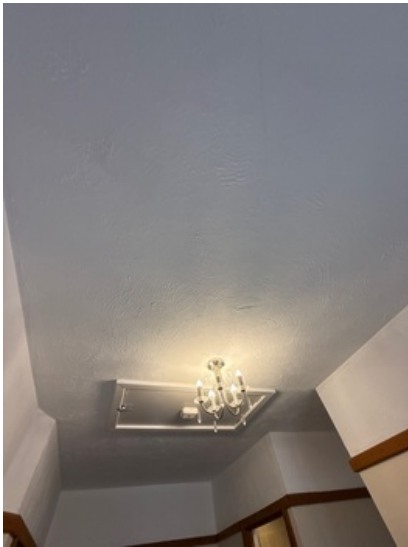
fragile nature of this type of construction, defects such as cracking and localized failure can occur. The risk of unevenness and further failure is likely to increase over time, and future repair or replacement works should be anticipated. Plasterboard ceilings, commonly referred to as "dry lining," are a popular method of finishing internal ceiling surfaces due to their cost efficiency and reduced drying times during construction. Plasterboard sheets are typically fixed to timber battens or metal frames. Cracks along plasterboard joints are not uncommon and are generally not structurally significant. Such cracks can usually be filled and repaired prior to redecoration.

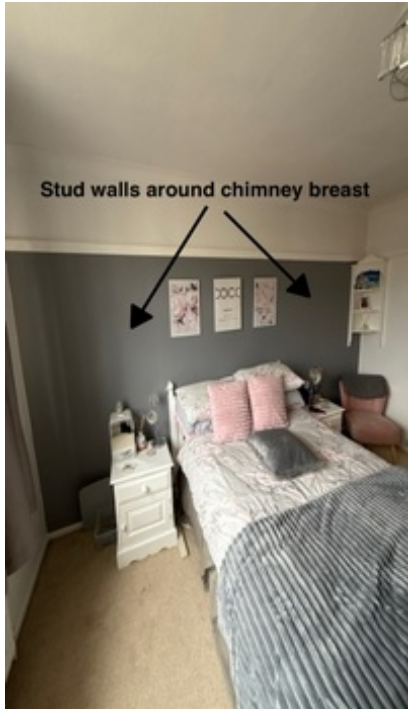
it is advisable to remove and cap the chimney pots at roof level to prevent water ingress and potential rain penetration. Additionally, redundant flues should be adequately ventilated, either by installing air bricks or using specially designed chimney pots that allow for ventilation at fireplace level, thereby reducing the risk of dampness and condensation within the chimney structure.

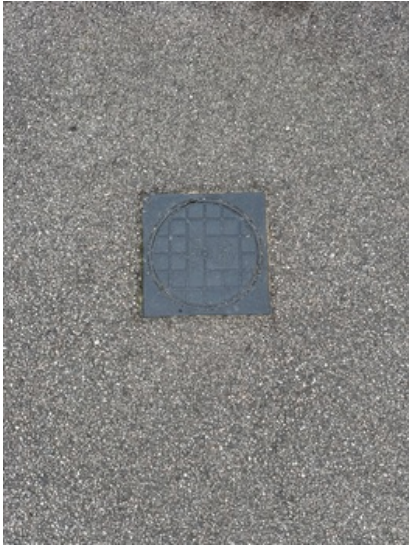
and neighbouring properties and therefore subject to demand related fluctuations in pressure. It would be prudent to confirm whether entire main water feed pipe has been renewed and if it is found lead pipework is still present, this is a material which can be hazardous to health and the original feed pipe should be stripped out and renewed.
