# Your survey report

Property address

South Surveyors - SAMPLE REPORT

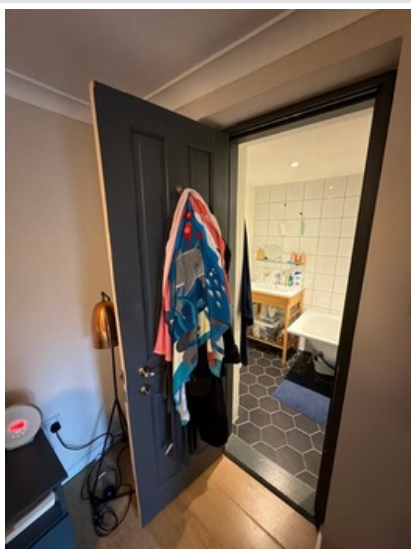
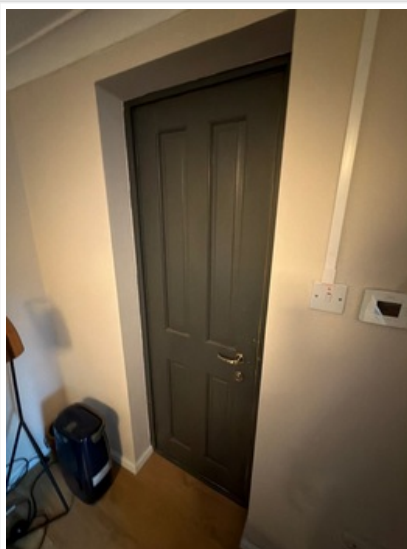
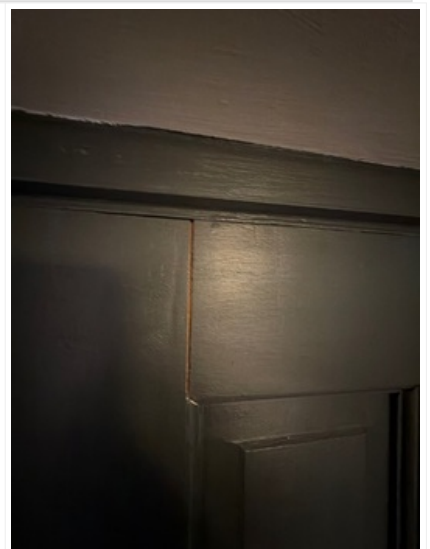
The internal joinery items includes; timber skirting boards, architraves, door frames, linings and doors together with the fitted kitchen and staircase. Some general marking and bruising is apparent consistent with normal wear and tear and some minor repairs will need to be carried out prior to redecoration. It would be prudent to provide mechanical extract ventilation to the kitchen to reduce the possibility of condensation problems occurring. There is a requirement for improvements to the room doors. It should be remembered that we have not taken out any of the kitchen appliances and cannot verify the adequacy of connections. Leaks can occur at any time between the date of survey and your taking occupation. If leaks are found when you take up occupation, you should not assume that they were visible, accessible or indeed in existence at the time of survey. Any such leaks should be promptly rectified. Removal of appliances can reveal or cause defects in plasterwork and services. This must be accepted when proceeding with your purchase.

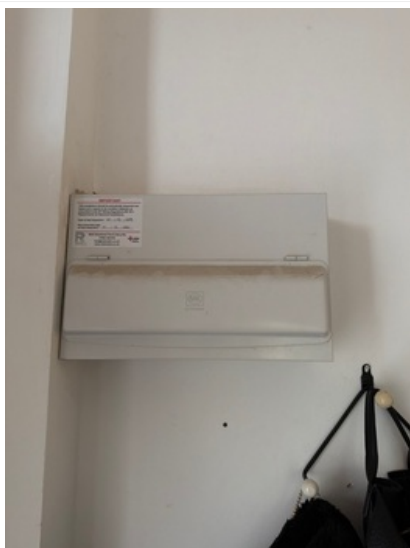
**Safety warning:** The Electrical Safety Council recommends that you should get a registered electrician to check the property and its electrical fittings at least every ten years, or on change of occupancy. All electrical installation work undertaken after 1 January 2005 should have appropriate certification. For more advice, contact the Electrical Safety Council.

**Safety warning:** Electrical Safety First recommends that you should get a registered electrician to check the property and its electrical fittings at least every ten years, or on change of occupancy. All electrical installation work undertaken after 1 January 2005 should have appropriate certification. For more advice contact Electrical Safety First.

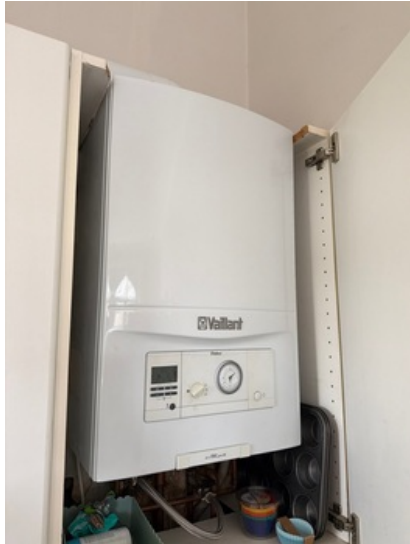
The heating is supplied by a gas fired boiler. This is a modern appliance and appears to be operating satisfactorily at the time of inspection. For precautionary purposes a heating engineer should examine the hot water and heating boiler and undertake appropriate servicing, with any recommendations to be implemented. The radiators and visible pipework appear in satisfactory condition, with no significant corrosion or leakages noted. A significant amount of the central heating pipework is buried within the construction and whilst there were no signs of leakage, this can occur undetected beneath floor finishes, particularly if pipework is not adequately protected We have not carried out any calculations and cannot confirm the heating is adequate to achieve satisfactory temperatures. We recommend that the system be assessed and if found to be inadequate, upgrading may be required. Condition Rating 3A - (Further investigation Required) – You should instruct a reputable qualified plumbing and heating engineer or a Gas Safe registered engineer undertake a combined inspection and test of the cold water, hot water and heating c services and report to you, before exchange of contracts.

Condition Rating 3A - (Further investigation Required) – You should instruct a reputable qualified plumbing and heating engineer or a Gas Safe registered engineer undertake a combined inspection and test of the cold water, hot water and heating c services and report to you, before exchange of contracts.

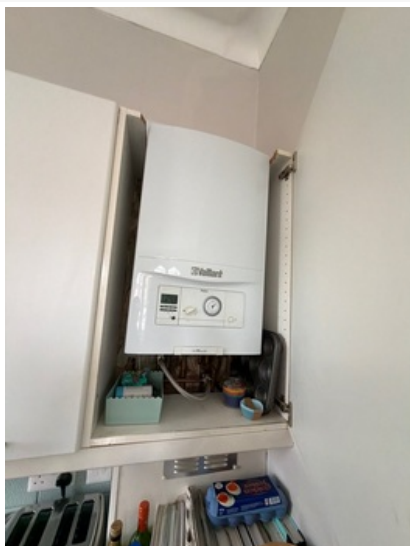
### F5 Water heating

Hot water is provided by the gas fired condensing boiler. The inspection of the services was limited to those areas which were visible. No comment can be made as to the condition of any services which are not visible. It should be appreciated that some service pipes and cables are covered and any access panels cannot be opened without disturbing decorations, therefore a full inspection was not possible. Some pipes and cables are provided below flooring, making inspection impracticable. In such circumstances the identification of leakages, if any, may not be possible. Services have not been tested but where appropriate specific advice has been made as to the advisability of having the services inspected by a specialist contractor. A number of water pipes are likely to pass through the space beneath the floor and concealed areas. When access to this area is next gained, these pipes should be properly insulated so they do not freeze during cold weather. Condition Rating 3A - (Further investigation Required) – You should instruct a reputable qualified plumbing and heating engineer or a Gas Safe registered engineer undertake a combined inspection and test of the cold water, hot water and heating c services and report to you, before exchange of contracts.

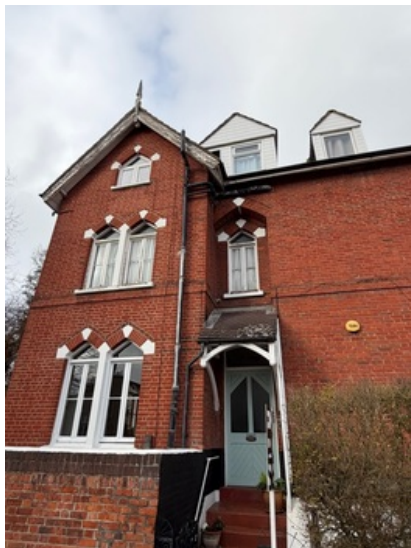
The property appears to be connected to the mains drainage system which is likely to be shared with the adjoining property. The exact location and direction of the underground drainage installation cannot be determined with accuracy and it would be prudent to complete utilities searches prior to commitment to purchase. The rainwater may be directed into the foul drains. This is acceptable if there is a combination foul and storm water drain, as was generally the case before the introduction of modern Building Regulations. If, however, there is a separate surface water drainage system it is not permissible to discharge surface water into the foul drain and vice versa. Your legal advisers should make appropriate enquiries on this matter with the Local Authority. The internal drainage was checked where accessible for leak and flushed checked for blockages, none was noted. There were no damage or other significant defect at the time of our inspection. The internal drainage system (traps, waste fitting and joints) is checked for leaking joints and rate of flow where accessible. Condition rating 3A – Further Investigation - You should instruct a reputable drainage contractor to inspect the drains and report to you, before exchange of contracts.

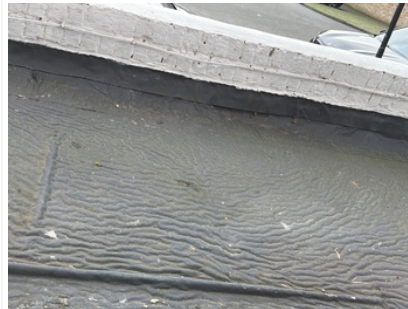
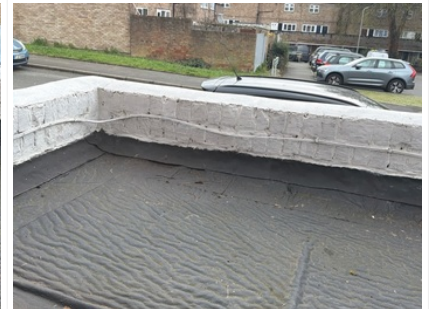
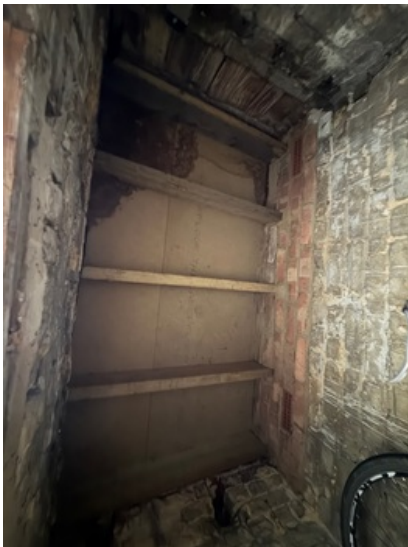
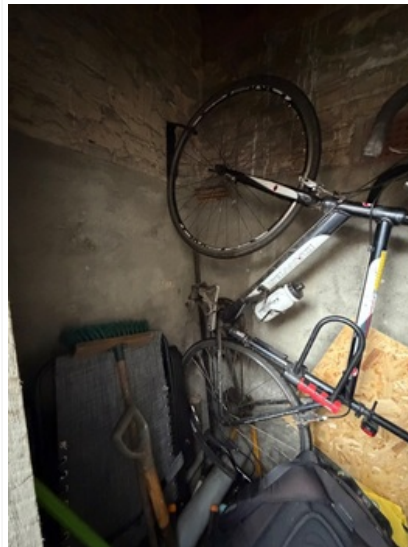
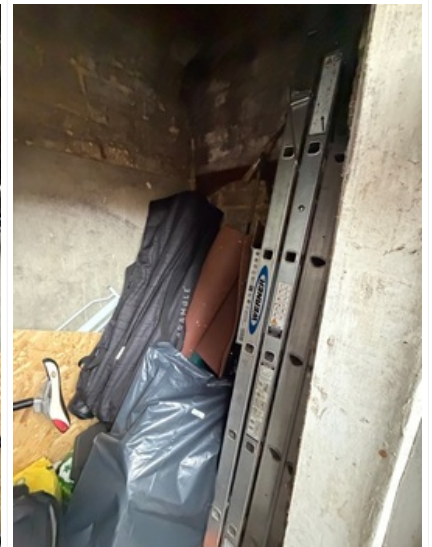
The store room is constructed with solid brick walls and is covered by a flat roof incorporating rubber and felt coverings. The internal inspection was limited due to stored items restricting access and visibility, and the risk of concealed defects within the store room must be accepted. Both the rubber membrane and felt covering to the flat roof of the store room have failed and are allowing water ingress into the structure. This is a significant defect that requires urgent attention. The failure of both roof coverings indicates that the roof has reached the end of its serviceable life and requires comprehensive remedial works. Water ingress through a failed flat roof can cause several serious problems including progressive deterioration of the roof structure and supporting timbers, wet rot and timber decay to roof joists, fascias, and other structural timbers, damage to internal wall surfaces and brickwork, mould growth creating potential health hazards, and worsening of the defect over time as water penetration accelerates deterioration of the roof structure. Given the confirmed water ingress through the failed roof covering, the roof timbers within the store room are at significant risk of water damage and potential decay. The timbers on the inside of the roof structure may need to be repaired or replaced depending on the extent of water damage sustained. A thorough inspection of all accessible roof timbers should be undertaken when the roof covering is removed during remedial works. Any timbers found to be affected by wet rot or significant water damage should be cut out and replaced with new pre-treated timber before the new roof covering is installed. It is important that the full extent of timber damage is assessed and addressed before a new roof covering is applied. Covering damaged or decaying timbers with a new roof membrane without addressing underlying timber defects will lead to premature failure of the new covering and more costly repairs in the future. The failed roof covering should be replaced as a matter of urgency to prevent further water ingress and progressive damage to the structure. Remedial works should include complete removal of the existing failed rubber membrane and felt covering, inspection and probing of all exposed roof timbers for signs of rot or water damage, replacement of any defective timbers with new pre-treated timber, installation of new falls or furring pieces if necessary to ensure adequate drainage, installation of a new flat roof covering using a modern durable system such as a single-ply membrane, GRP fibreglass, or EPDM rubber system with appropriate edge detailing, upstands, and flashings, and provision of adequate drainage falls to prevent water ponding on the new roof surface. The new roof covering should be installed by a specialist flat roofing contractor with experience in modern flat roof systems. The works should be accompanied by a manufacturer's guarantee and contractor's guarantee for both materials and workmanship, typically for a minimum of ten to twenty years depending on the system specified. The walls of the store room are of solid brick construction. Our inspection of the internal walls was limited due to stored items restricting access and visibility. The risk of concealed defects to the internal wall surfaces and brickwork must be accepted. Given the confirmed water ingress from the failed roof covering, there is an increased risk that internal wall surfaces may have been affected by water penetration and dampness. When the store room is cleared of stored items, the

walls should be inspected thoroughly for signs of water staining, dampness, deterioration of brickwork or pointing, and mould growth. Any defects discovered should be addressed as part of the remedial works programme. When the new roof covering is installed, careful attention should be paid to ensuring adequate drainage falls are provided to direct rainwater away from the structure. Inadequate falls are a common cause of flat roof failure, as standing water accelerates deterioration of the covering. The junction between the flat roof and any adjacent walls should be properly weathered with appropriate upstands and flashings to prevent water ingress at these vulnerable junctions.

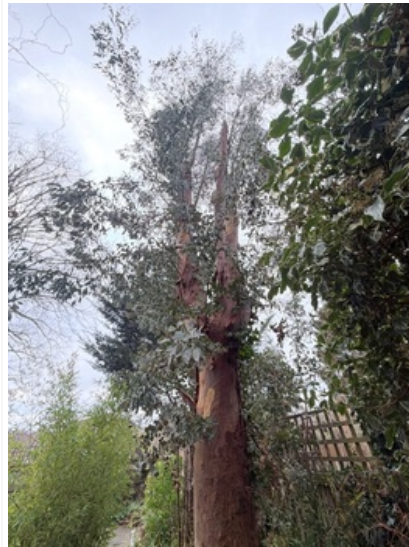
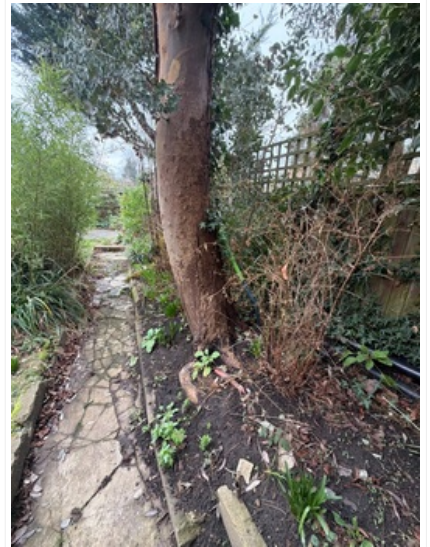
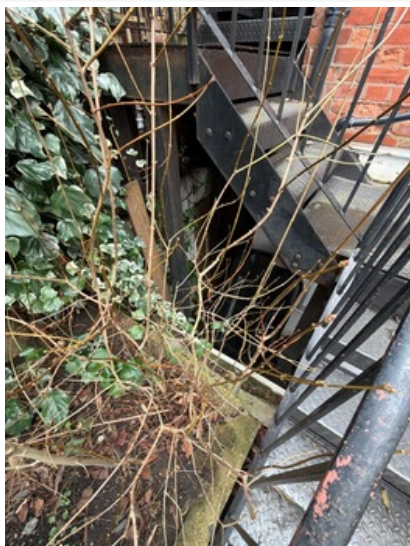
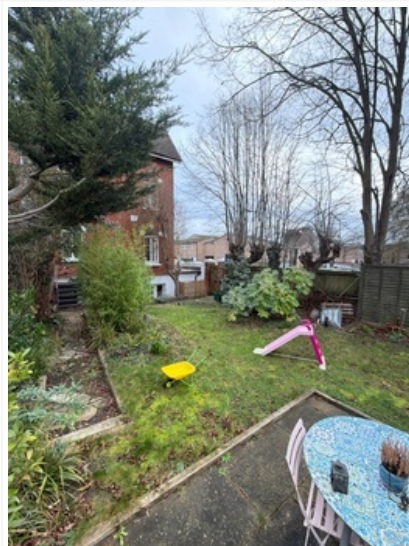
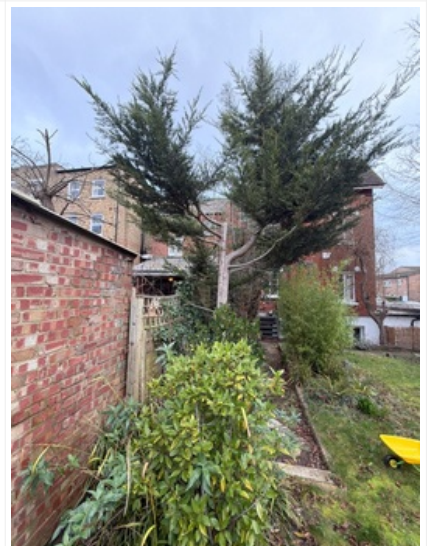
Subsoils in the area may be of clay which may be subject to seasonal change. There is a shared areas, which is in poor condition at present and for which there may be shared maintenance costs; legal advisers to confirm. There is no evidence of previous flooding although further advice is available via the Environment Agency website and through your local searches. The land at the rear slopes towards the property and it would be prudent to introduce drainage adjacent to the property. There are several trees within the vicinity of the property. There is the potential for root spread towards drainage channels and the property, although no associated damage was observed to warrant further investigation. It would be prudent for periodic maintenance to be undertaken to the trees, to ensure that they remain in healthy condition and so assist in minimising against the potential for falling branches. Consideration should also be given to periodic pruning to prevent them becoming too large. Tall growing hedging was observed on neighbouring land, which is considered to dominate the subject property. There are regulations in place with respect to height and location of hedges in proximity to neighbouring properties, which we understand are controlled by the Local Authority. If this issue is of concern, clarification with your legal adviser is recommended prior to legal commitment to purchase, to assist in minimising against any potential for legal disputes or having any adverse effects on saleability of the subject property. To the rear of the property there is an external staircase providing access. At the time of inspection, no handrails or guidance rails were provided. The absence of suitable guarding and handrails represents a potential health and safety hazard, particularly in wet or icy conditions where the risk of slips and falls is increased. Current Building Regulations and general health and safety guidance would normally expect adequate handrails and guarding to be installed where there is a change in level. We recommend that a suitably qualified contractor installs appropriate handrails and guarding to improve user safety and reduce the risk of injury. Additionally, there is a separate steel staircase to the rear of the building serving another flat. This staircase is showing signs of corrosion, with visible rusting to the metal components. Corrosion can compromise the structural integrity of the staircase over time if not properly addressed. The affected areas should be thoroughly cleaned back to bare metal, treated with a suitable rust inhibitor, and redecorated with appropriate protective coatings. If corrosion is found to be extensive upon closer inspection, localised repairs or partial replacement of affected sections may be necessary. A competent contractor should be instructed to further assess the extent of deterioration and carry out remedial works as required. Pathways may be slippery in wet or icy conditions. You should upgrade paths and patios, which are in need of improvement. Boundary clarification It is recommended that a certified copy of the Deed Plans be obtained and boundaries checked on site, with any discrepancies investigated further, to assist in reducing the possibility of boundary disputes with adjoining owners. Responsibilities for boundaries are unknown and repair liabilities should be investigated further. Boundaries are provided with timber fences and brick walls. Much of the boundaries were concealed and you should anticipate that ongoing maintenance and repair will be required. There are retaining walls/

boundary walls to the rear. These types of feature require high levels of maintenance and are currently poor condition. Only on-street parking is available which may be at a premium during peak times. The property appears to be located beneath a flight path and some noise disturbance may be apparent. There is a right of way across the rear of the property. Legal advisers should confirm full details. There is a lamp post close to the property and some light pollution may be apparent. Whilst there was no evidence of any adverse easements, servitudes or wayleaves affecting the property your legal advisers should be asked to verify. See Section H.3.
