LEVEL 3

# Your survey report

Property address  
Sample Report Road  
London  
BRX XXX

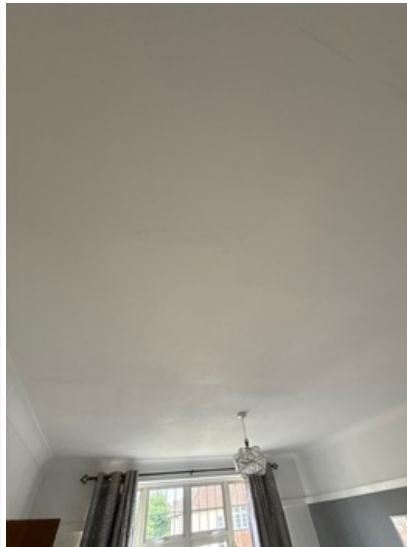
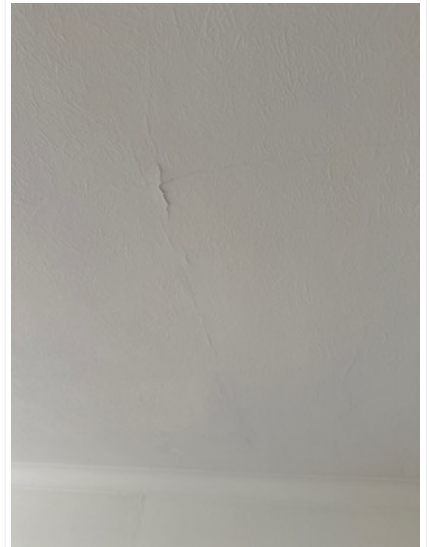
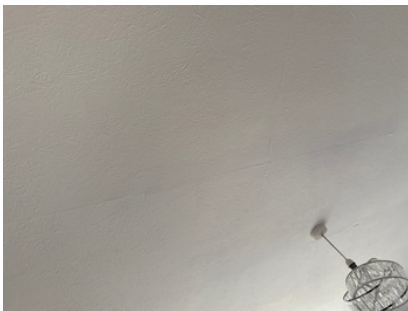
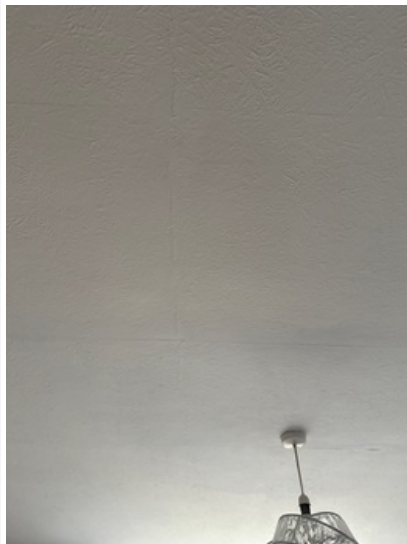
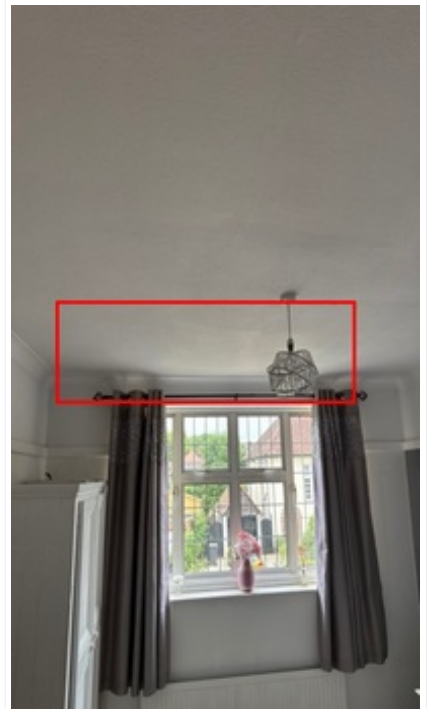
The ceilings were inspected visually from within the rooms, with no opening-up or intrusive investigations undertaken. The ceilings comprise a combination of traditional lath and plaster and more modern plasterboard finishes, both typically skimmed and painted. In areas where plasterboard ceilings are present, it is possible that original lath and plaster ceilings have been overboarded. However, we are unable to confirm whether the plasterboard is adequately secured to the ceiling joists. Lath and plaster ceilings are inherently vulnerable to cracking, loosening, and general deterioration as they age. Due to the relatively

fragile nature of this type of construction, defects such as cracking and localized failure can occur. The risk of unevenness and further failure is likely to increase over time, and future repair or replacement works should be anticipated. Plasterboard ceilings, commonly referred to as "dry lining," are a popular method of finishing internal ceiling surfaces due to their cost efficiency and reduced drying times during construction. Plasterboard sheets are typically fixed to timber battens or metal frames. Cracks along plasterboard joints are not uncommon and are generally not structurally significant. Such cracks can usually be filled and repaired prior to redecoration.

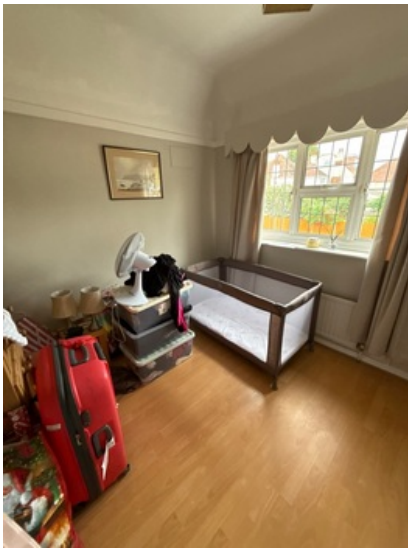
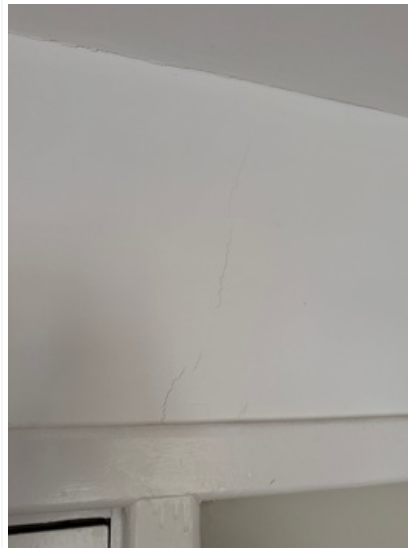
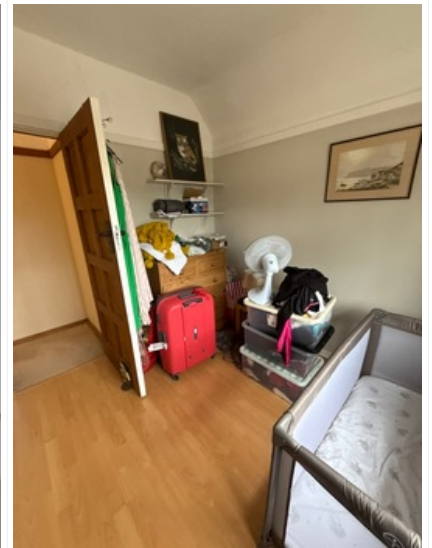
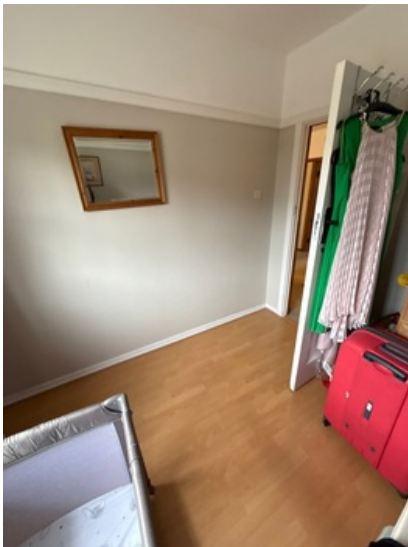
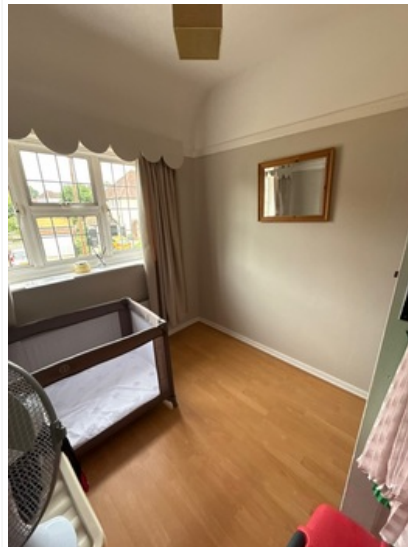
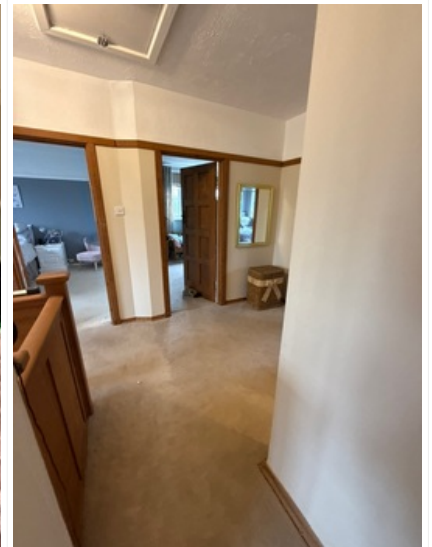
The internal walls comprise a mixture of solid construction, likely brickwork, and modern timber stud partitions with plasterboard linings. Wet areas are finished with ceramic tiling to reduce the risk of moisture ingress. Wallpaper finishes are present on some walls, with paint applied over both wallpaper and plastered surfaces. At the time of inspection, these finishes were generally in satisfactory condition. Structurally, the internal walls appear sound, with no significant evidence of internal structural movement. Some general cracking and minor distortion were observed, particularly at the junctions between walls and ceilings, and around door and window openings. Such cracking is common in properties and typically results from normal shrinkage and minor building movement. These defects are largely cosmetic in nature and should not cause undue concern. Usually, careful preparation and cosmetic repair prior to redecoration will suffice. Moisture content readings were taken throughout the walls using an electronic damp meter. High levels of dampness was detected in the third bedroom. (See attached photos) It is recommended that you seek quotations from a reputable Property Care Association (PCA) registered contractor for the necessary remedial works.

Such works are likely to include upgrading or renewing the damp-proof course and replastering of affected internal wall surfaces.

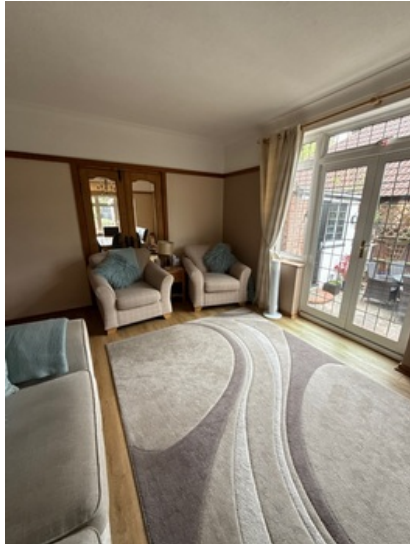
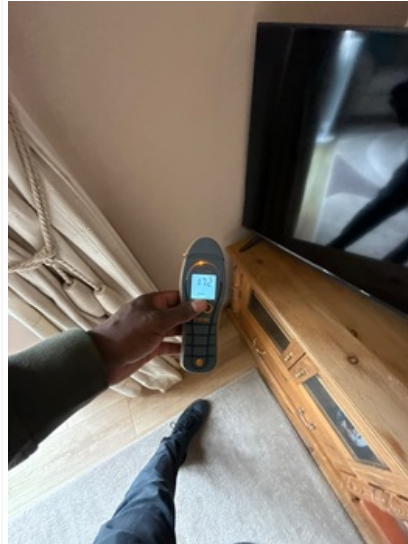
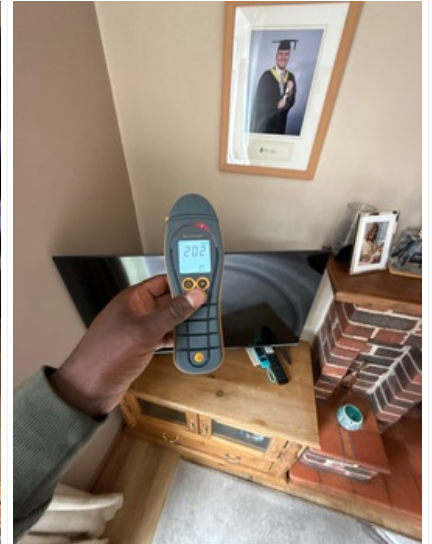
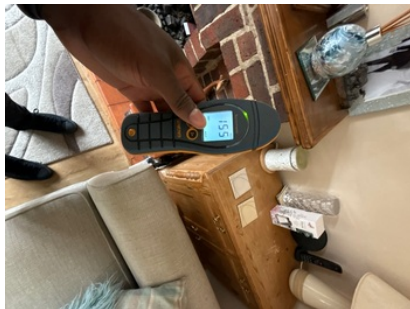
The floors throughout the property are primarily of suspended timber construction. Inspection was limited by fitted floor coverings and furniture, which restricted detailed examination. Comments are therefore based on selected areas where floor coverings could be lifted or edges turned back to reveal the underlying construction and condition. It should be noted that concealed defects may exist beneath the floor coverings, and this risk must be accepted. Where accessible and walked upon, the suspended timber floors exhibited minor springiness and some unevenness. These characteristics are common in older domestic properties and are considered to be within acceptable limits, with no structural significance noted. Areas beneath sanitary fittings could not be inspected due to the impracticality and invasiveness of lifting coverings in these locations. Consequently, the possibility of concealed defects exists. Solid floors, where present, appeared firm and level underfoot as observed through the floor finishes. However, it is recognised that solid floors can consolidate over time, potentially creating hollows beneath the surface or, in extreme cases, causing significant deflection. Additionally, expansion or impurities within the sub-floor structure may lead to damage.

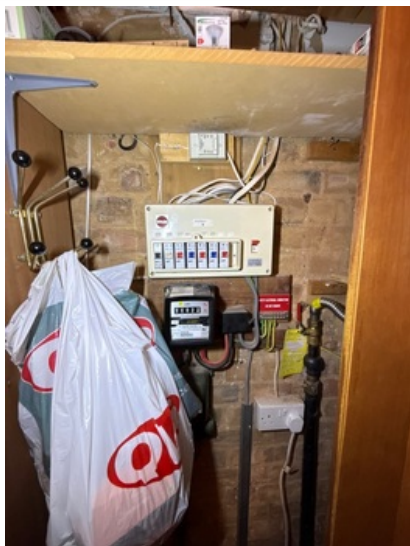
**Safety warning:** The Electrical Safety Council recommends that you should get a registered electrician to check the property and its electrical fittings at least every ten years, or on change of occupancy. All electrical installation work undertaken after 1 January 2005 should have appropriate certification. For more advice, contact the Electrical Safety Council.

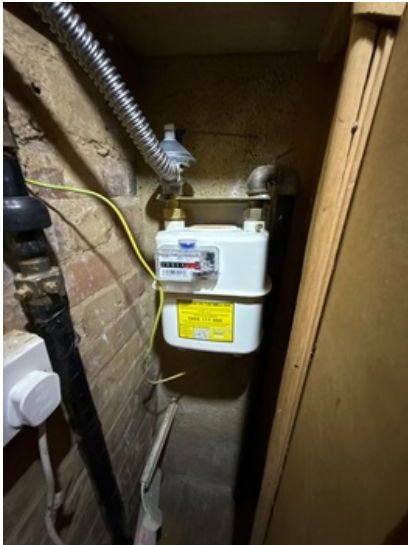
### F2 Gas/oil

**Safety warning:** All gas and oil appliances and equipment should regularly be inspected, tested, maintained and serviced by a registered 'competent person' and in line with the manufacturer's instructions. This is important to make sure that the equipment is working correctly, to limit the risk of fire and carbon monoxide poisoning and to prevent carbon dioxide and other greenhouse gases from leaking into the air. For more advice contact the Gas Safe Register for gas installations, and OFTEC for oil installations.

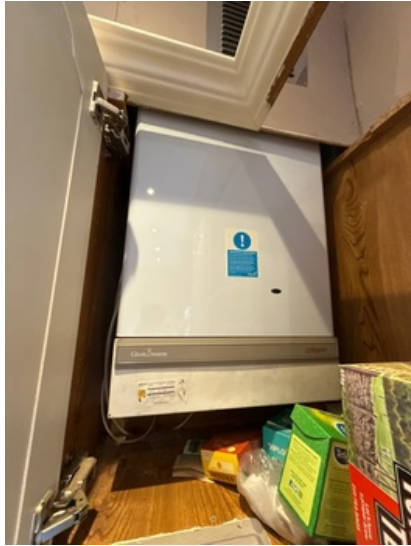
### F5 Water heating

Hot water is provided by the gas fired condensing boiler. Hot water is provided by the gas/oil fired boiler and also by an immersion heater fitted to the hot water storage cylinder. The inspection of the services was limited to those areas which were visible. No comment can be made as to the condition of any services which are not visible. It should be appreciated that some service pipes and cables are covered and any access panels cannot be opened without disturbing decorations, therefore a full inspection was not possible. Some pipes and cables are provided below flooring, making inspection impracticable. In such circumstances the identification of leakages, if any, may not be possible. Services have not been tested but where appropriate specific advice has been made as to the advisability of having the services inspected by a specialist contractor. A number of water pipes are likely to pass through the space beneath the floor and concealed areas. When access to this area is next gained, these pipes should be properly insulated so they do not freeze during cold weather. Condition Rating 3A - (Further investigation Required) – You should instruct a reputable qualified plumbing and heating engineer or a Gas Safe registered engineer undertake a combined inspection and test of the cold water, hot water and heating c services and report to you, before exchange of contracts.

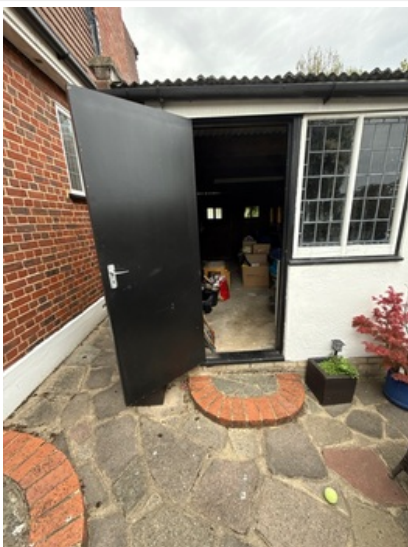
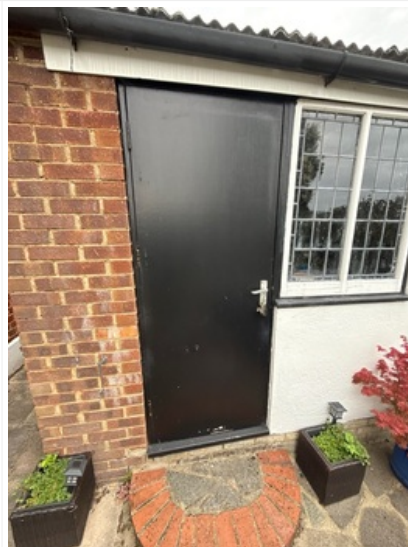
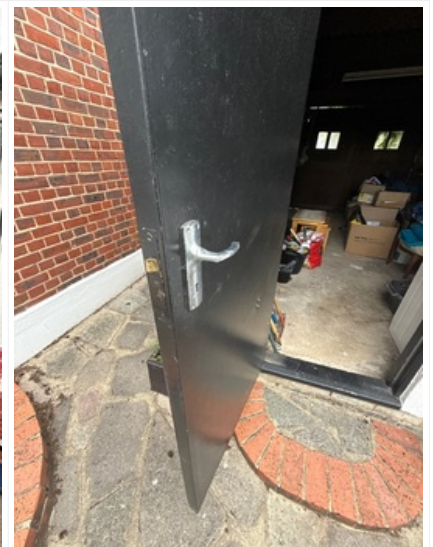
The garage is constructed using traditional building methods and materials, consistent with standard practices for ancillary outbuildings of this type. The external walls are formed of solid brickwork, providing a stable and durable enclosure. Internally, the partitions are also constructed from solid materials, contributing to the overall robustness of the structure. The floor is of solid concrete construction, which offers a hardwearing, low-maintenance surface suitable for vehicle storage or the placement of heavy equipment. Concrete floors of this kind generally perform well in terms of load-bearing capacity and long-term durability. Vehicular access is provided by timber doors which, although typically secure and long-lasting, can be prone to deterioration over time as a result of environmental exposure. In particular, issues such as rot or misalignment may affect both security and functionality. It is recommended that the condition and operation of the doors be checked to ensure they remain serviceable. The garage roof is of flat construction and is finished with a mineral felt covering. While this material provides a basic level of weather protection, it is known to degrade over time, particularly under exposure to ultraviolet radiation, temperature fluctuations, and standing water. In this instance, the roof was observed to be in poor condition, exhibiting signs of advanced wear and deterioration, with a likelihood of water ingress. Given the current condition of the roof and the age-related wear noted elsewhere, a more detailed inspection by a qualified roofing contractor is advised. Remedial works, likely including replacement of the felt covering, should be undertaken to ensure the garage remains weathertight, secure, and fit for continued use.
